Geoenvironmental Appraisal

Land at Shires Lane, Embsay For The Devonshire Group

Report no: 3161/1A

Date: November 2018

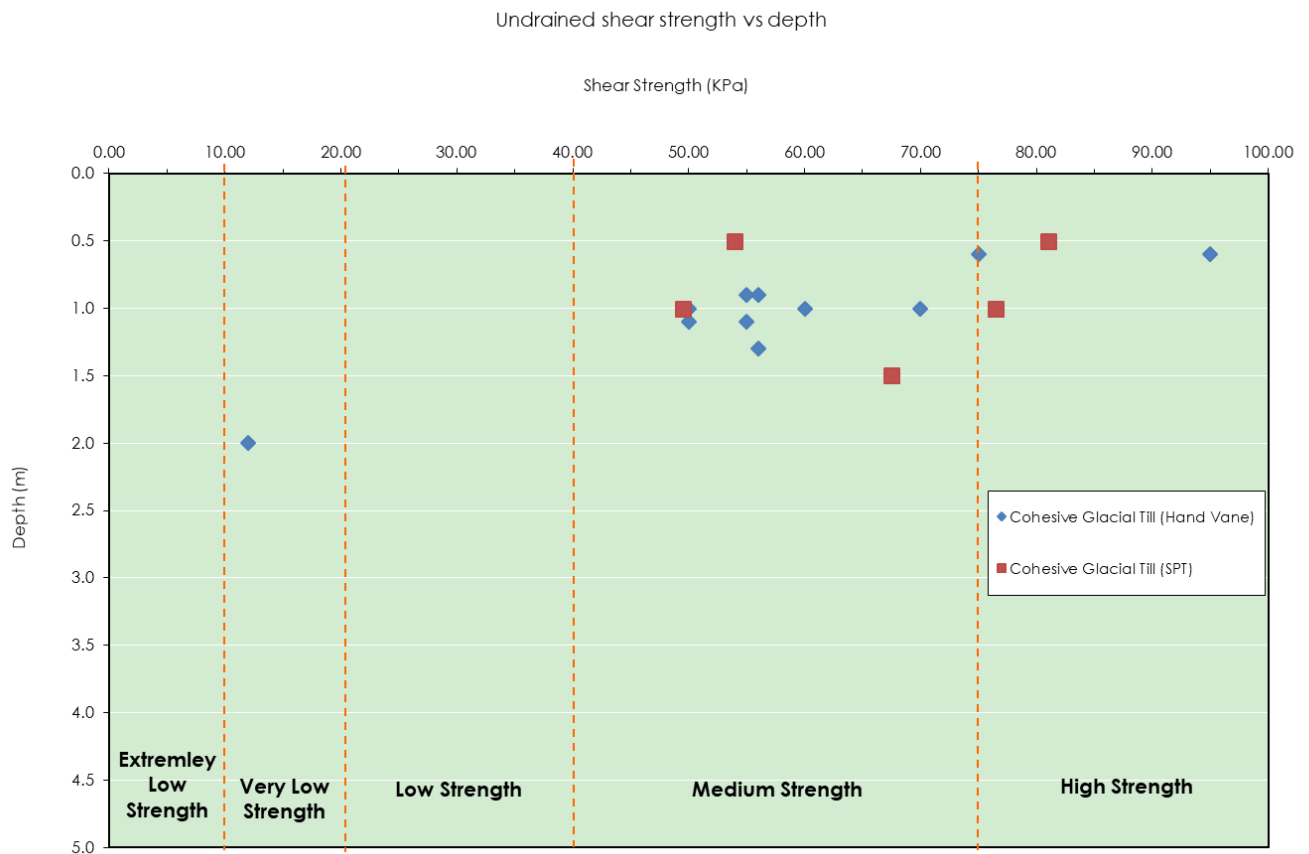
- 11.5.1 Hand shear vane testing was undertaken within trial pits in-situ to around 1.2m depth and from larger blocks of excavated clay below that depth.
- 11.5.2 The results are summarised within the plot below. Results are typically around 50kPa to 70kPa (medium strength), with two readings of >75kPa (high strength). The single result within the 'very low strength' range (12kPa in TP1 @ 2.0m) was taken in a localised softer bed of clay (extending from 1.7m to 2.9m).
- 11.5.3 It should be noted that the Glacial Till was often too gravelly/sandy to obtain meaningful hand vane readings from, and that other beds of 'soft' material were recorded in TP2 (1.3m to 2.0m), TP3 (1.3m to 2.1m) and TP5 (1.6m to 1.8m).

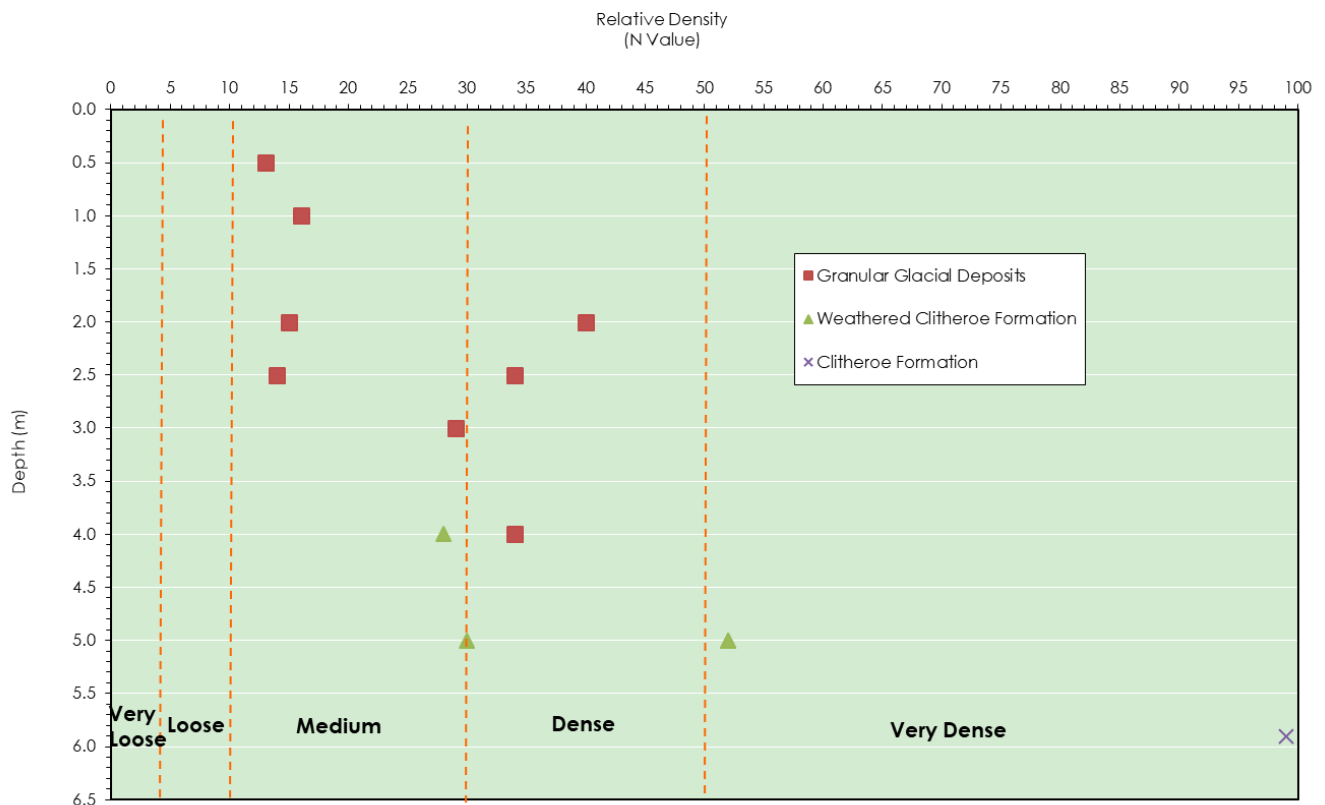
11.6.3 The reported blow counts suggest densities ranging from medium dense to very dense. However, boulders are considered to be the probable cause of high blow counts and true densities are more likely to fall within the medium dense range.

11.6.4 The plot below presents a summary of SPT 'N' values.

11.6.5 The above results show that all granular soils can be regarded as being of at least medium dense.

- 11.6.1 The in-situ relative density of granular soils was established by carrying out Standard Penetration Tests (SPTs) during the drilling of the cable percussion boreholes. In addition, SPT test results can be broadly equated to an undrained shear strength where carried out within cohesive deposits; these results have been included within the summary of shear strengths plot above.

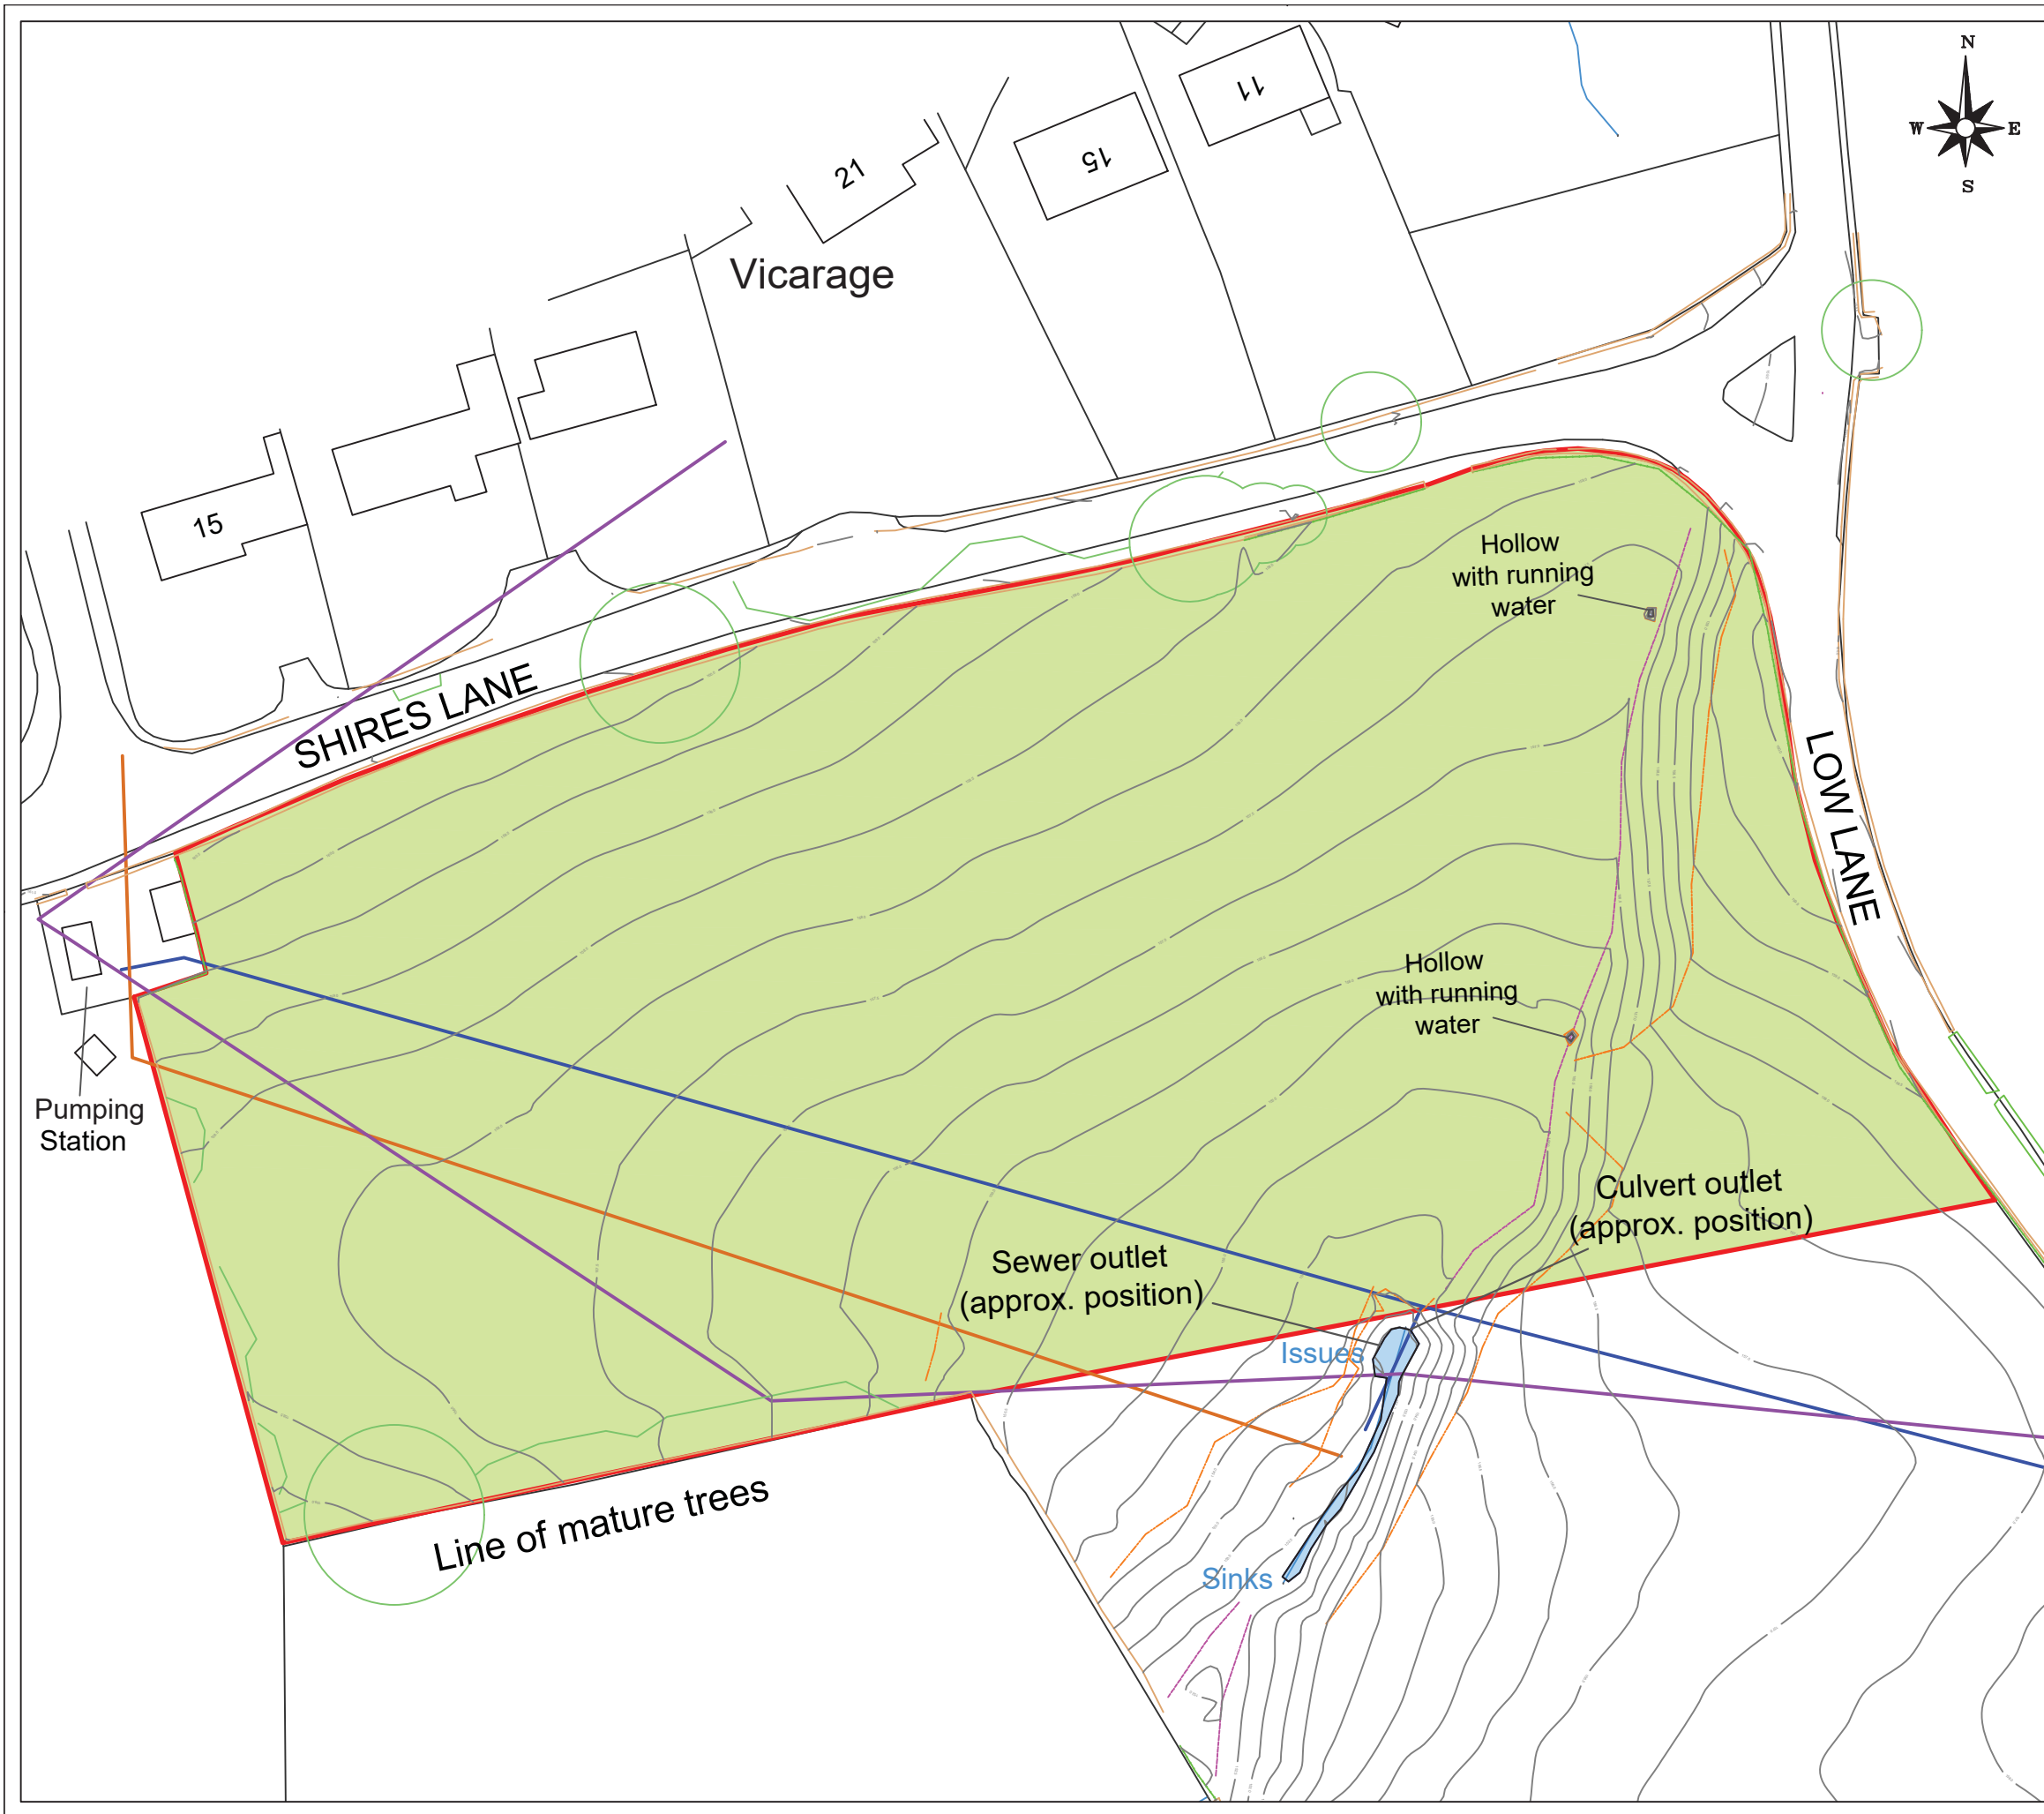
SITE FEATURES

- NOTES
- POND/SURFACE WATER
 - GRASS & OVERGROWN AREAS
 - LINE OF WATER UTILITY
 - LINE OF SEWER/DRAINAGE UTILITY
 - LINE OF BT/TELECOMMS UTILITY
- NOTE THAT UTILITY LOCATIONS SHOULD NOT BE RELIED UPON FOR CONSTRUCTION PURPOSES, NOR SHOULD IT BE ASSUMED THAT ALL UTILITIES BENEATH THE SITE ARE SHOWN ON THIS PLAN. THERE MAY BE UTILITIES UNKNOWN TO LITHOS. THIS DRAWING IS NOT AN ALTERNATIVE TO VISUAL INSPECTION, USE OF A CAT DETECTION TOOL AND CAREFUL EXCAVATION.
- APPROXIMATE SITE BOUNDARY

- 2.2.9 It should be noted that the line of the water main and sewer (taken from Yorkshire Water plans and superimposed onto Drawing 3161/3) do not match with the position of the outlet pipes around the pond (also shown on Drawing 3161/3).
- 2.2.10 Walking northwards along the base of the slope, there are two locations where 'hollows' can be seen, exposing flowing water (Green Bottom Beck) below. The hollows look to be a result of gaps in concrete/boulders which have been placed over the top of the culverted watercourse, and are of limited depth (<1m). One of the hollows had plastic-coated cables running through; the origin or purpose of these is not clear.
- 2.2.11 Although marked on service records, there was no evidence of an overhead BT cable (recorded position from service plans shown on Drawing 3131/3).

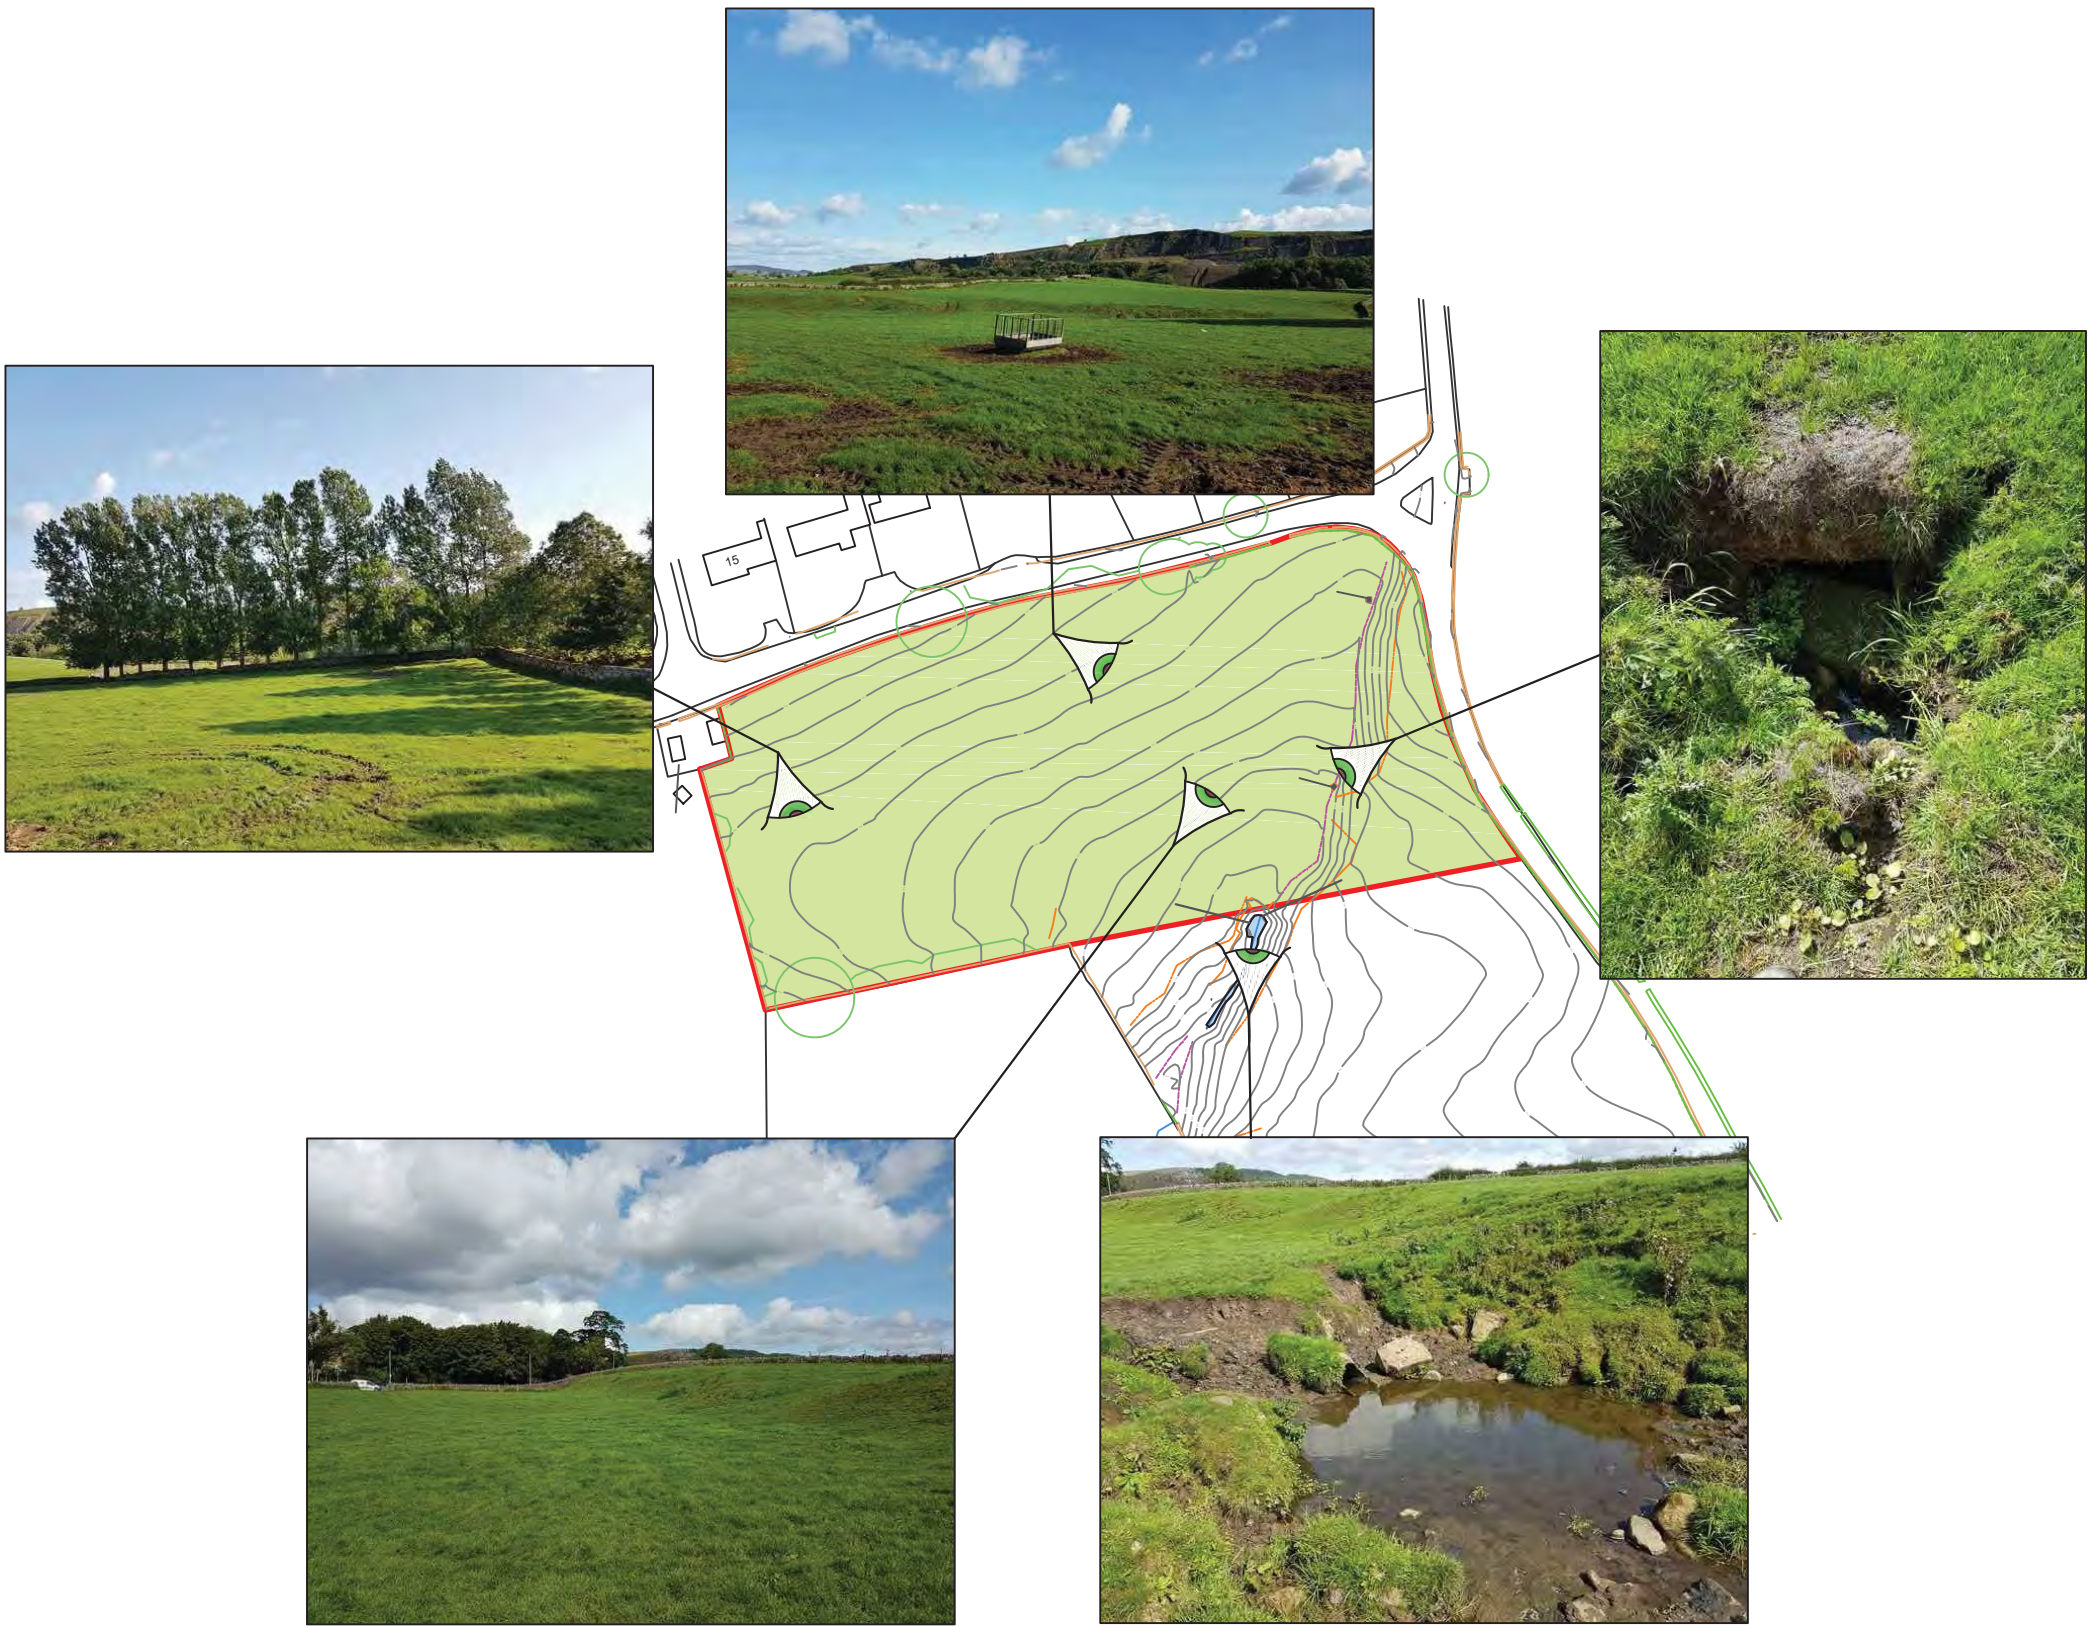
DRAWN		DATE	STATUS	
MJT		24/09/2018	FOR COMMENT <input type="checkbox"/>	
CHECKED		DATE	FOR APPROVAL <input type="checkbox"/>	
REG		24/09/2018	DRAFT <input type="checkbox"/>	
			FINAL <input checked="" type="checkbox"/>	
SCALE		SHEET	DRAWING NO.	REVISION
1:750		A3	3161/3

— APPROXIMATE SITE BOUNDARY

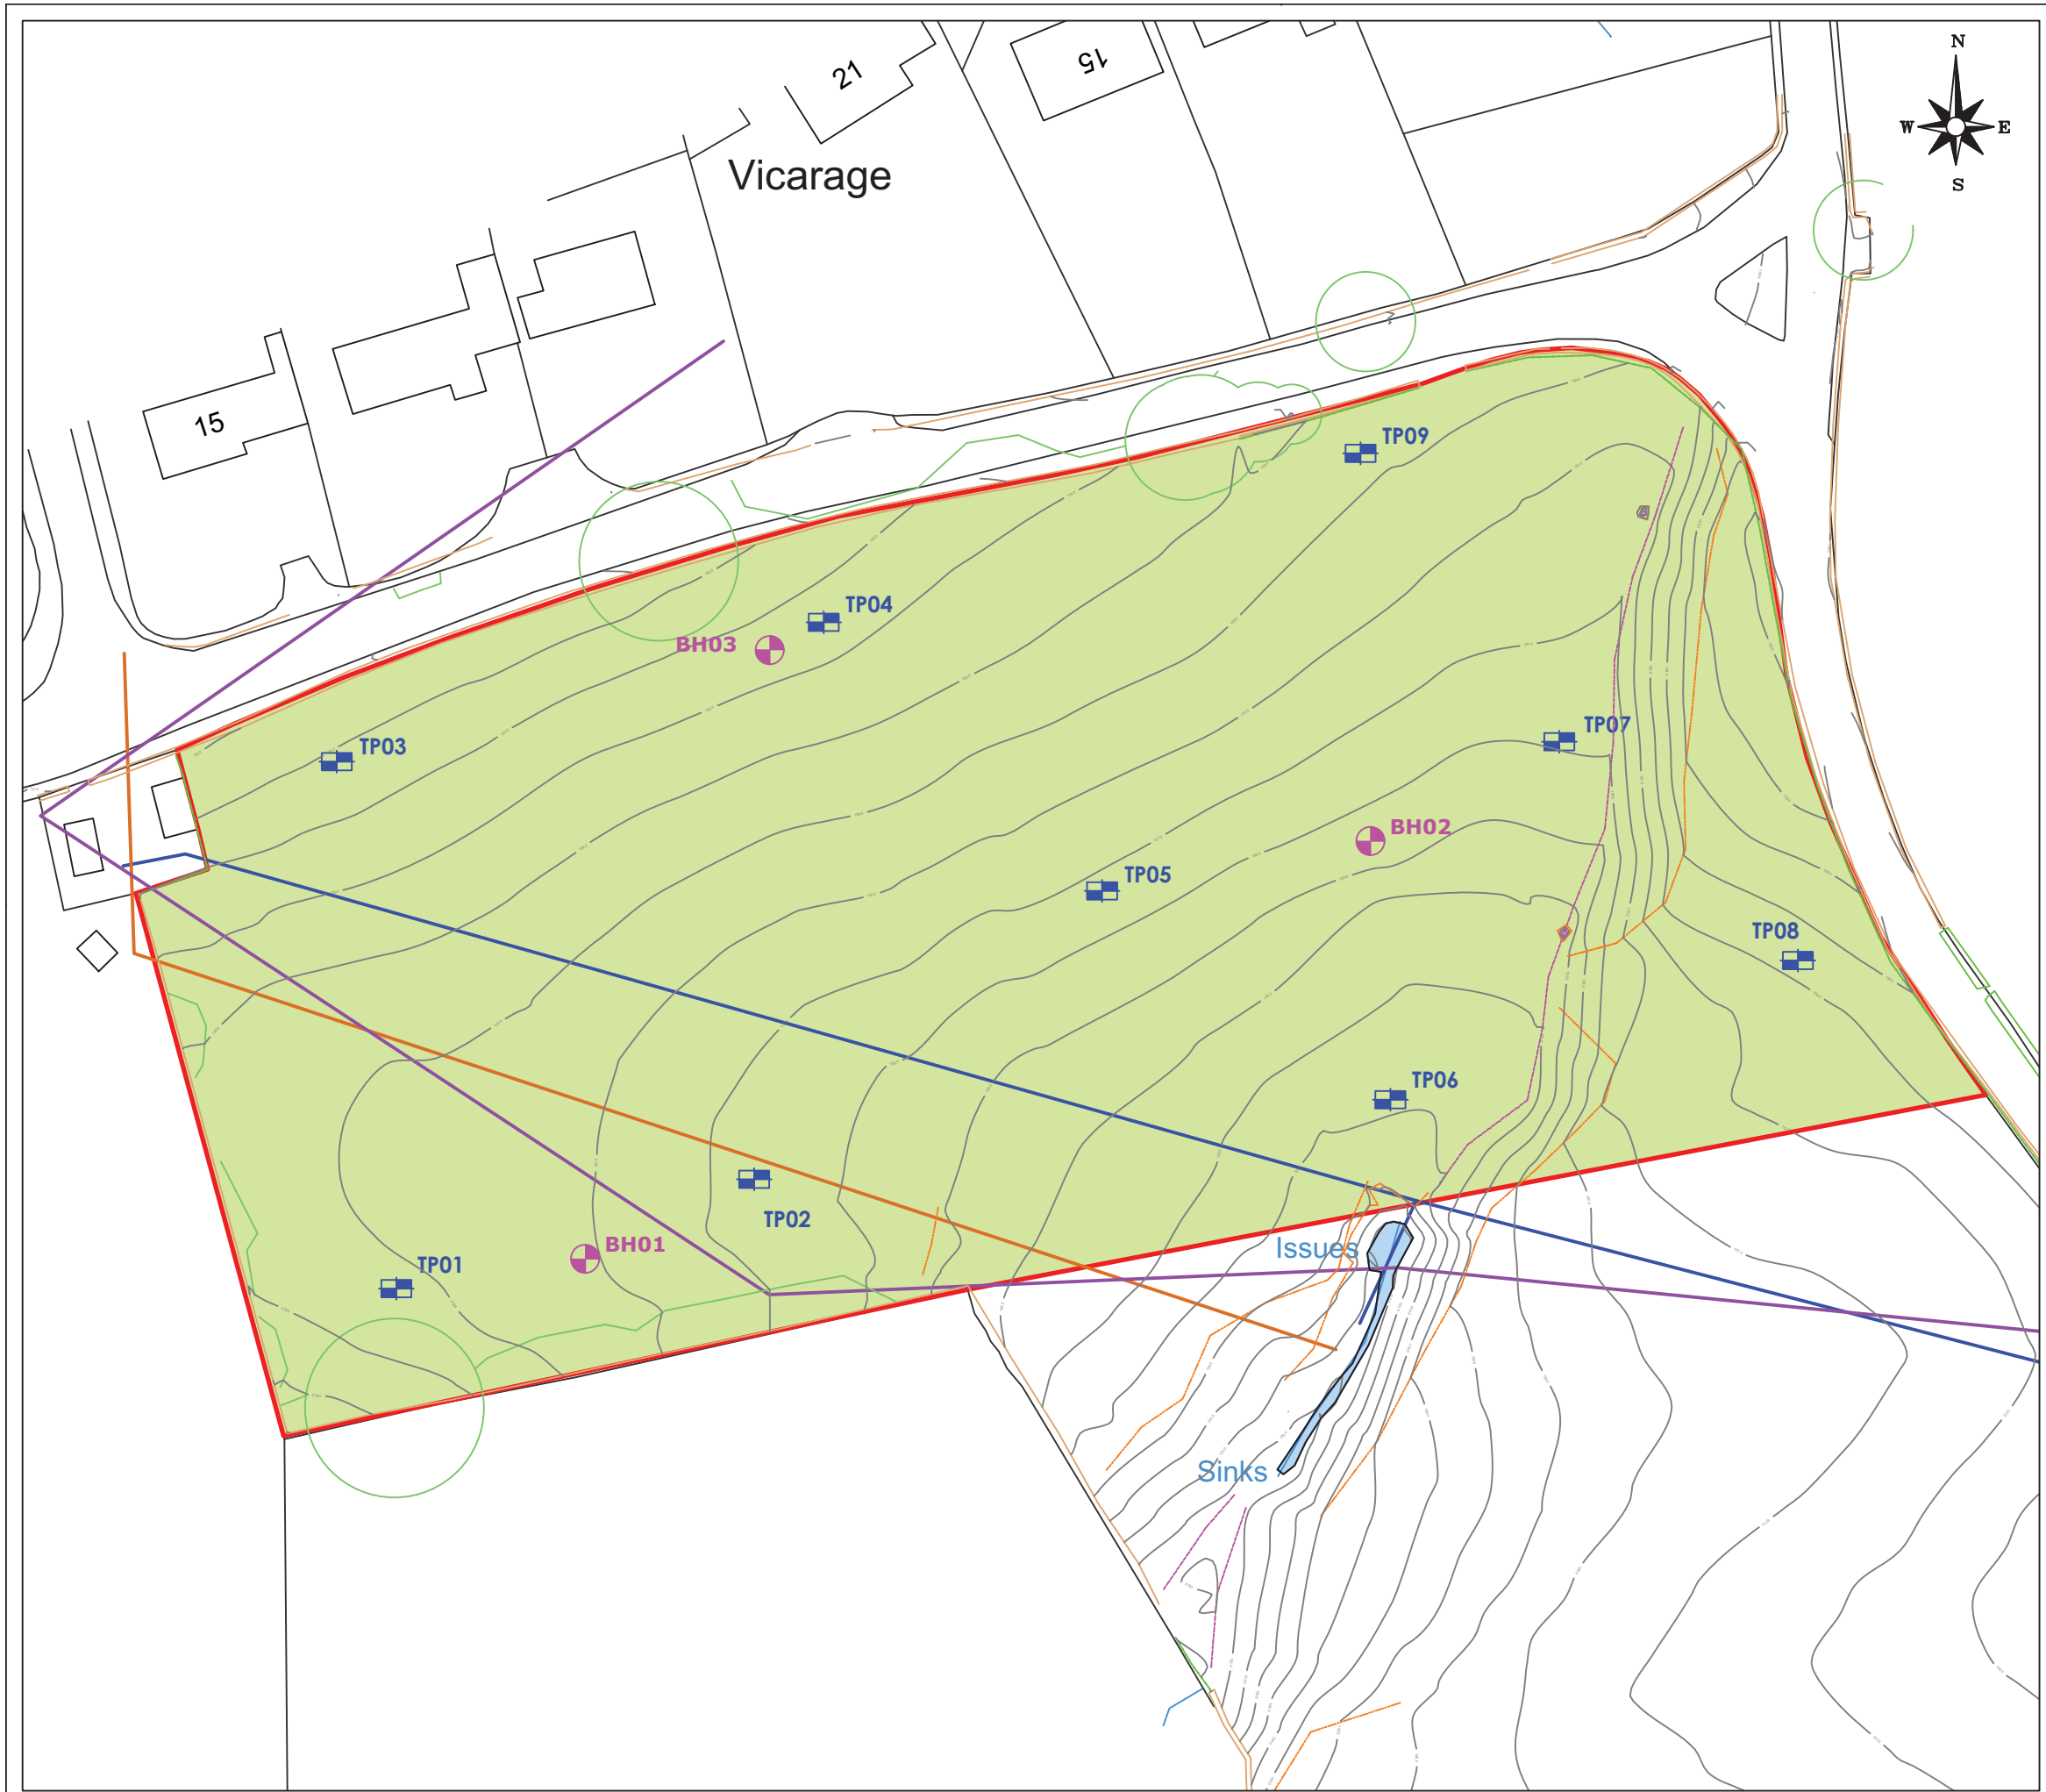
- TRIAL PIT LOCATION
- GRASS & OVERGROWN AREAS
- CABLE PERCUSSION LOCATION
- LINE OF WATER UTILITY
- LINE OF SEWER/DRAINAGE UTILITY
- LINE OF BT/TELECOMMS UTILITY

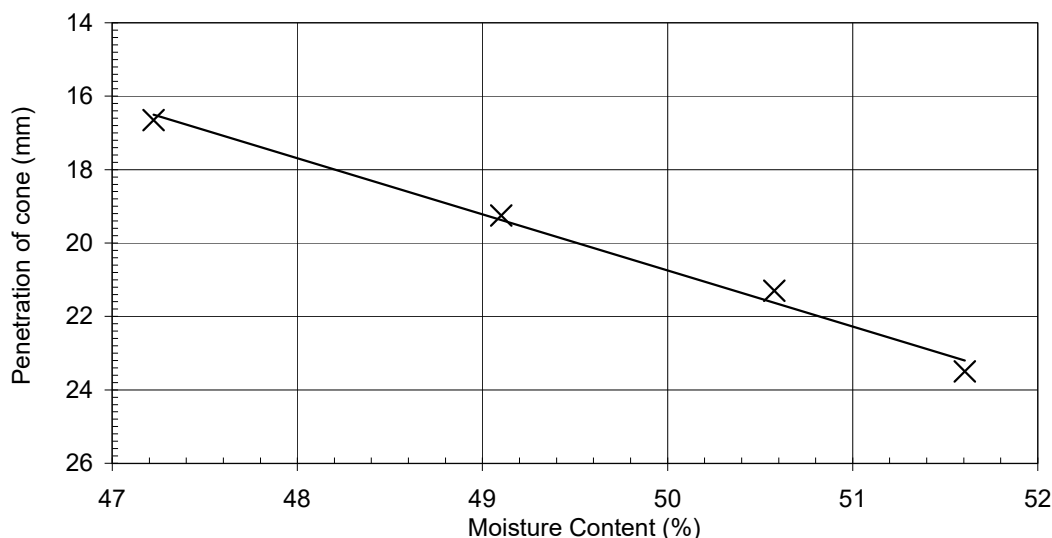
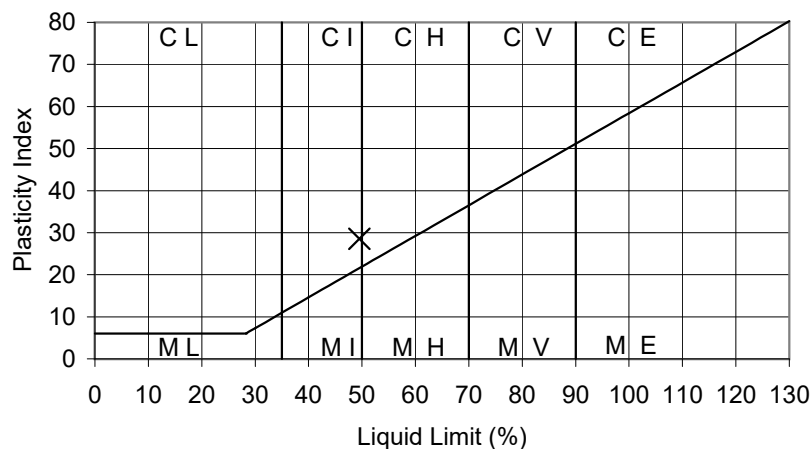
Non Engineering Description : Brown silty CLAY with some gravel. Gravel is fine to medium.

As Received Moisture Content : (BS1377:Part 2:Clause 3:1990) 21 %
 Percentage retained on 425µm sieve : 23 %
 Liquid Limit : 50 %
 Plastic Limit : 21 %
 Plasticity Index : 29
 Equivalent moisture content of material passing 425µm sieve : 27 %
 Liquidity Index : 0.21

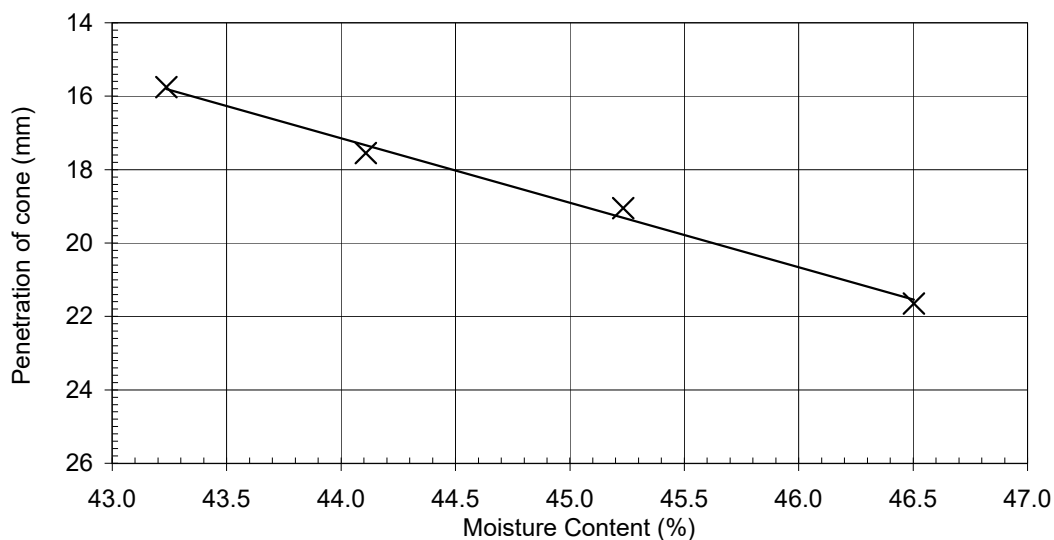
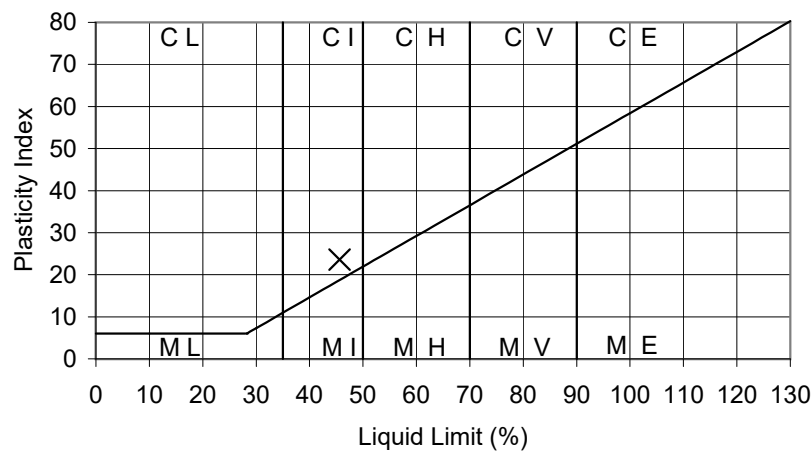
Non Engineering Description : Grey fine to coarse GRAVEL and COBBLES with much very clayey sand.

As Received Moisture Content : (BS1377:Part 2:Clause 3:1990) 20 %
 Percentage retained on 425µm sieve : 35 %
 Liquid Limit : 46 %
 Plastic Limit : 22 %
 Plasticity Index : 24
 Equivalent moisture content of material passing 425µm sieve : 31 %
 Liquidity Index : 0.38

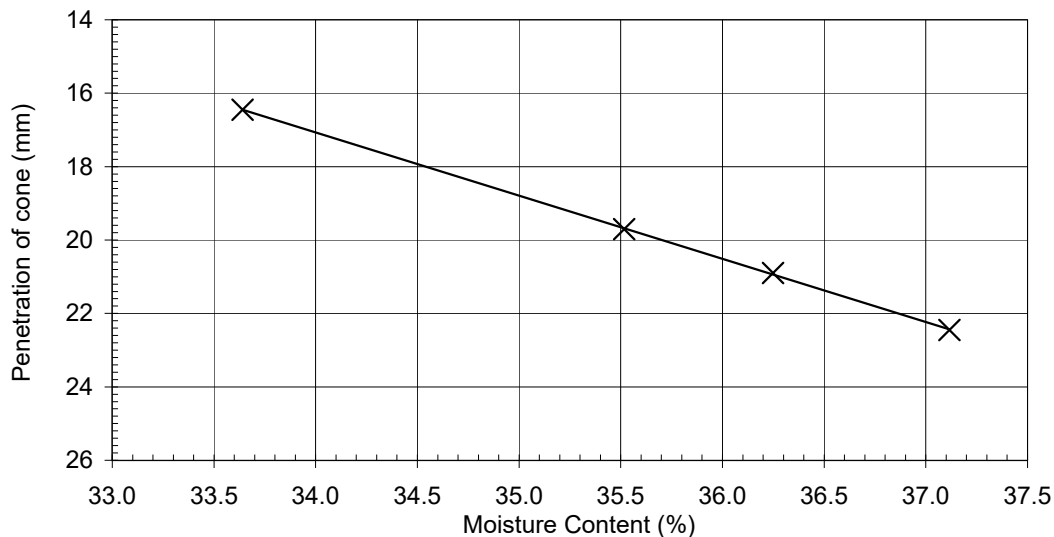
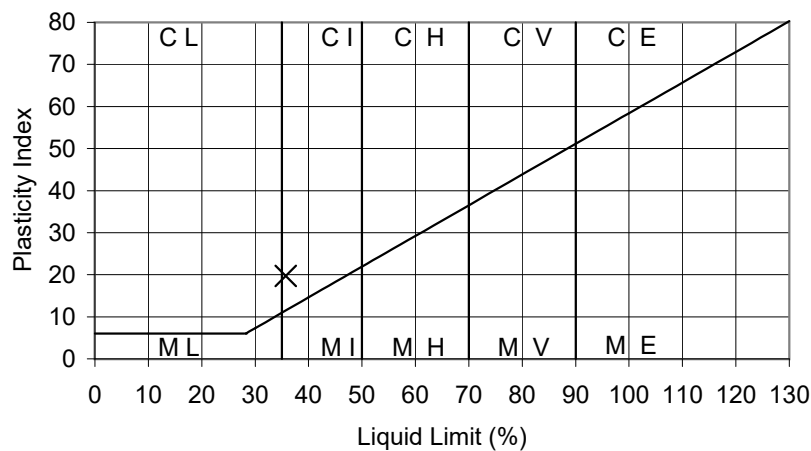
Non Engineering Description : Grey very clayey SAND with some gravel. Gravel is fine to coarse.

As Received Moisture Content : (BS1377:Part 2:Clause 3:1990) 20 %
 Percentage retained on 425µm sieve : 36 %
 Liquid Limit : 36 %
 Plastic Limit : 16 %
 Plasticity Index : 20
 Equivalent moisture content of material passing 425µm sieve : 31 %
 Liquidity Index : 0.75

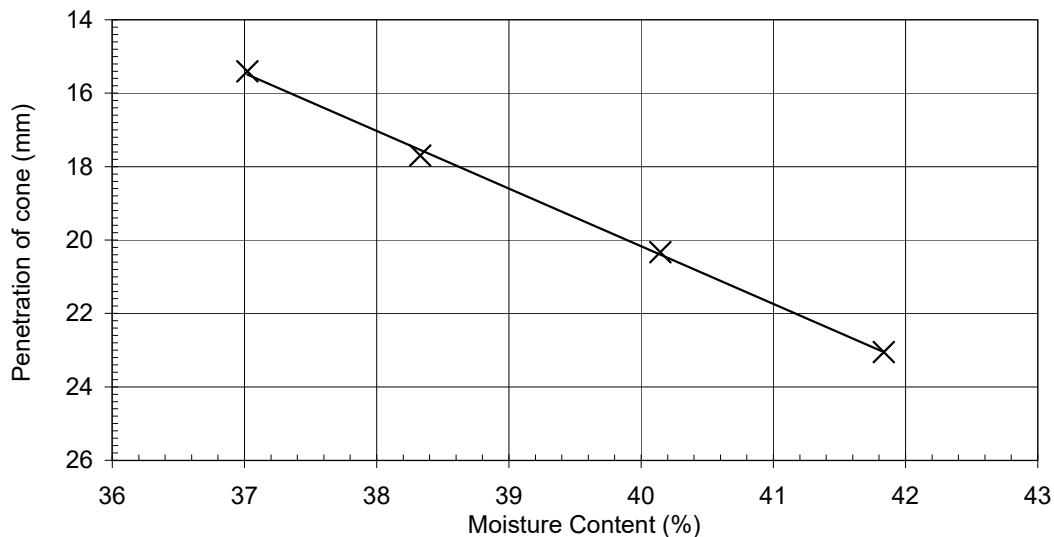
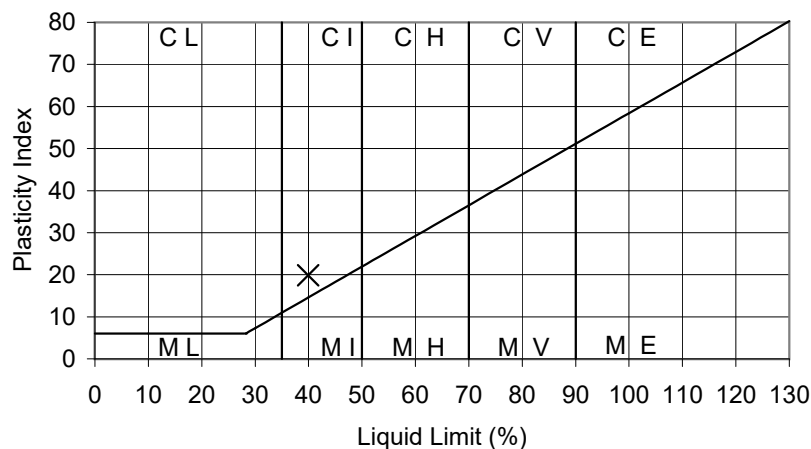
Non Engineering Description : Brown sandy CLAY with some gravel. Gravel is fine to medium.

As Received Moisture Content : (BS1377:Part 2:Clause 3:1990)	21 %
Percentage retained on 425µm sieve :	21 %
Liquid Limit :	40 %
Plastic Limit :	20 %
Plasticity Index :	20
Equivalent moisture content of material passing 425µm sieve :	27 %
Liquidity Index :	0.35

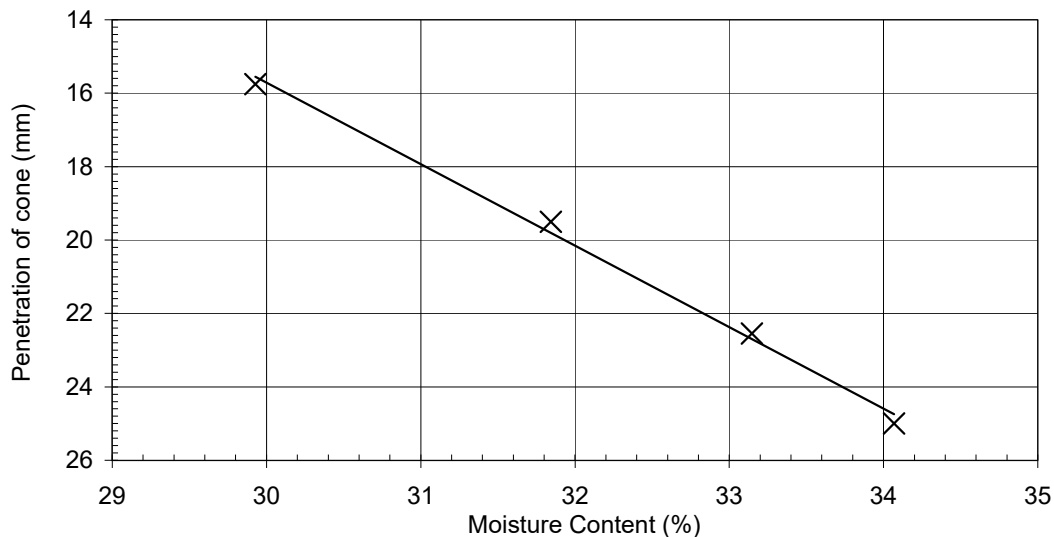
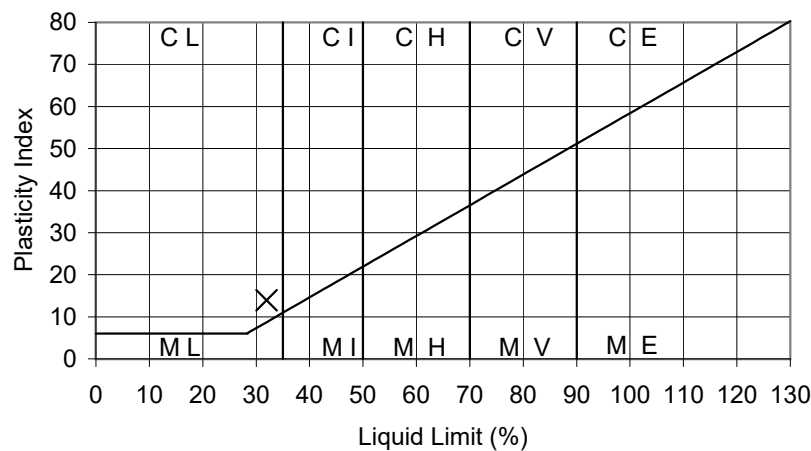
Non Engineering Description : Grey very sandy CLAY with much gravel. Gravel is fine to coarse.

As Received Moisture Content : (BS1377:Part 2:Clause 3:1990) 15 %
 Percentage retained on 425µm sieve : 44 %
 Liquid Limit : 32 %
 Plastic Limit : 18 %
 Plasticity Index : 14
 Equivalent moisture content of material passing 425µm sieve : 27 %
 Liquidity Index : 0.64

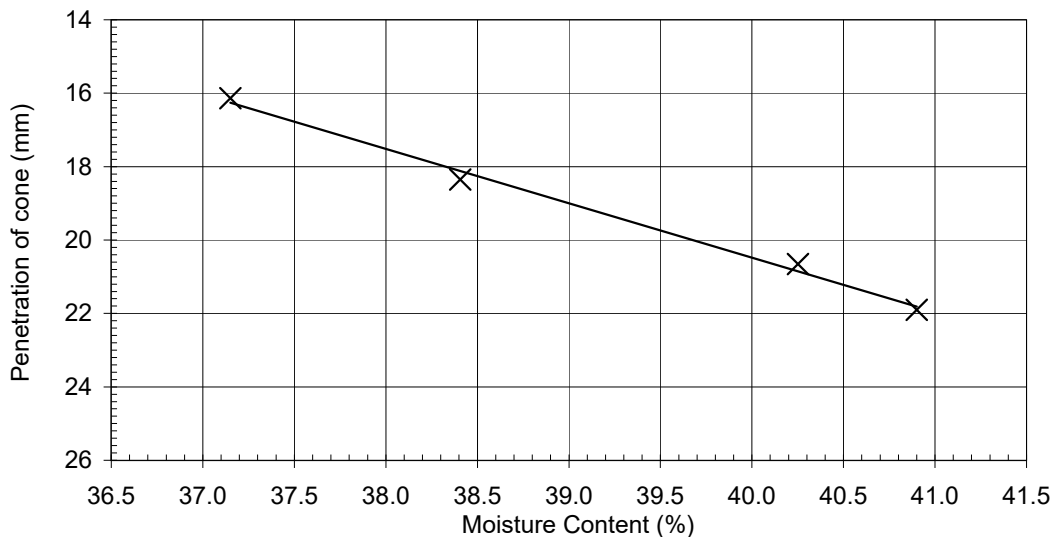
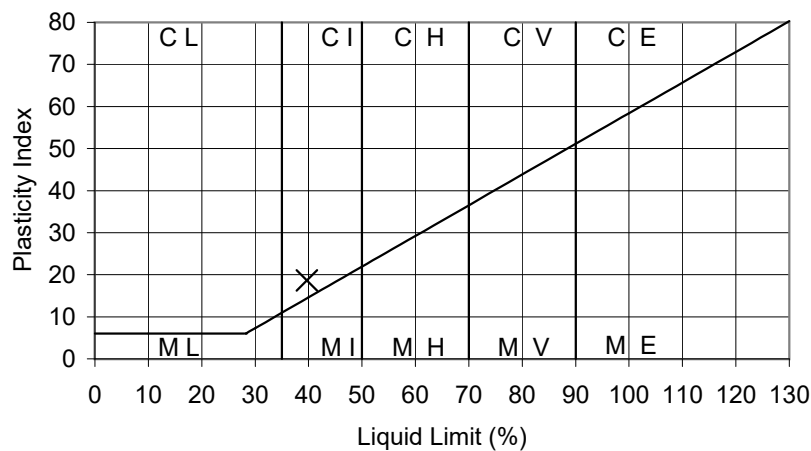
Non Engineering Description : Brown CLAY with some gravel. Gravel is fine to medium.

As Received Moisture Content : (BS1377:Part 2:Clause 3:1990) 25 %
 Percentage retained on 425µm sieve : 8 %
 Liquid Limit : 40 %
 Plastic Limit : 21 %
 Plasticity Index : 19
 Equivalent moisture content of material passing 425µm sieve : 27 %
 Liquidity Index : 0.32

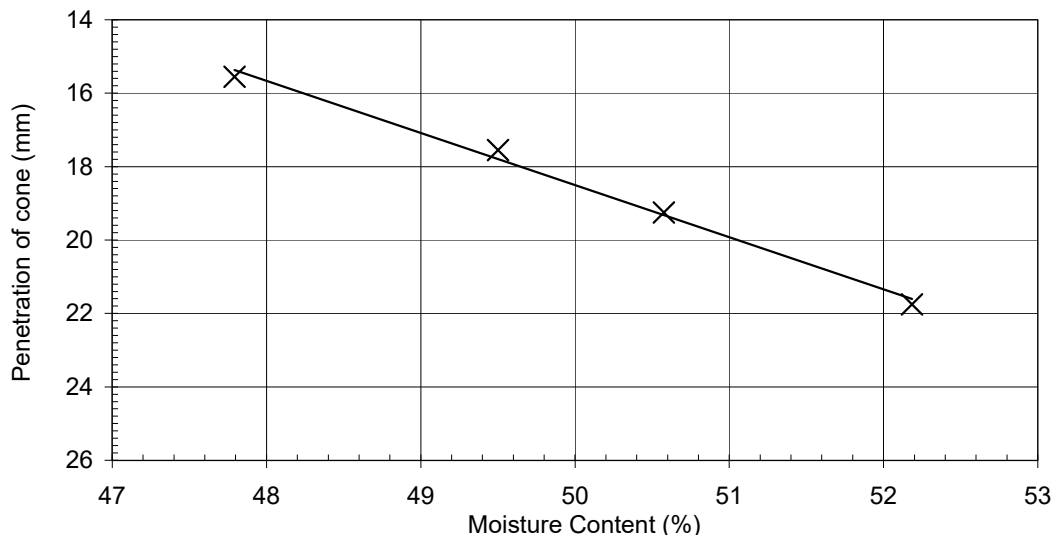
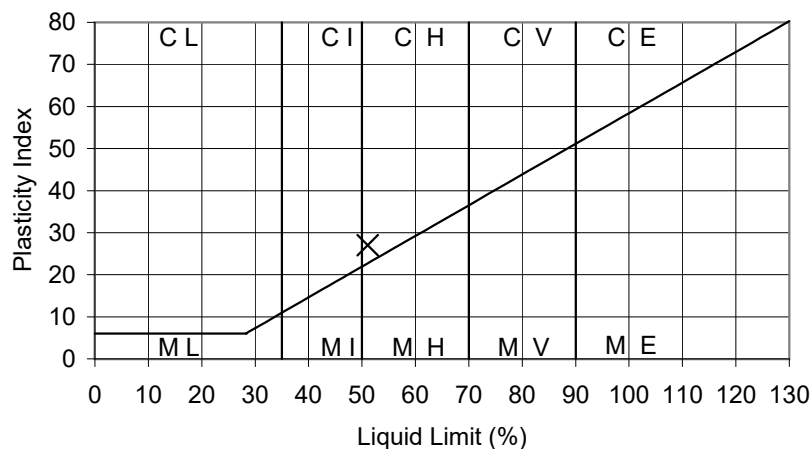
Non Engineering Description : Brown CLAY with much gravel. Gravel is fine to coarse.

As Received Moisture Content : (BS1377:Part 2:Clause 3:1990) 23 %
 Percentage retained on 425µm sieve : 29 %
 Liquid Limit : 51 %
 Plastic Limit : 24 %
 Plasticity Index : 27
 Equivalent moisture content of material passing 425µm sieve : 32 %
 Liquidity Index : 0.30

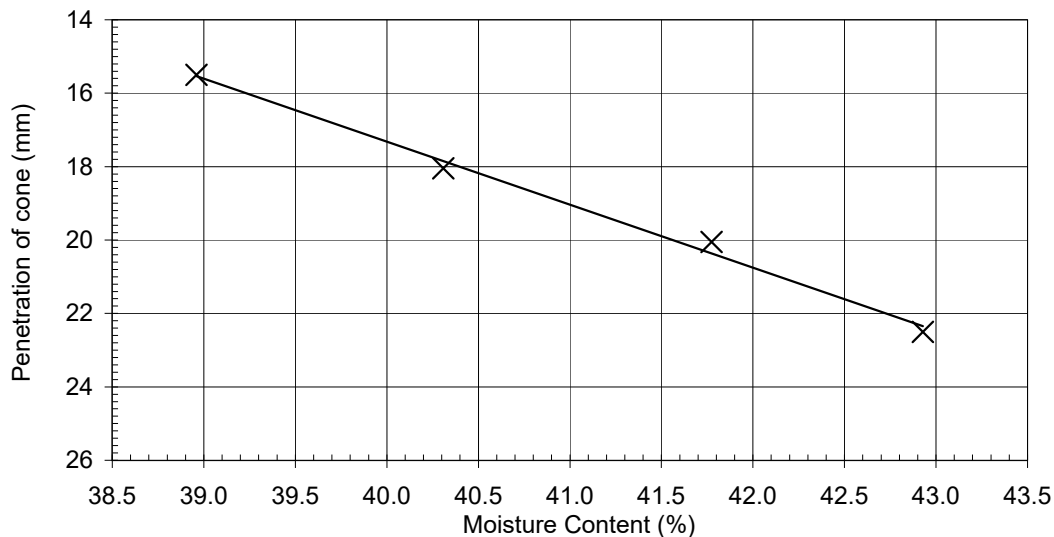
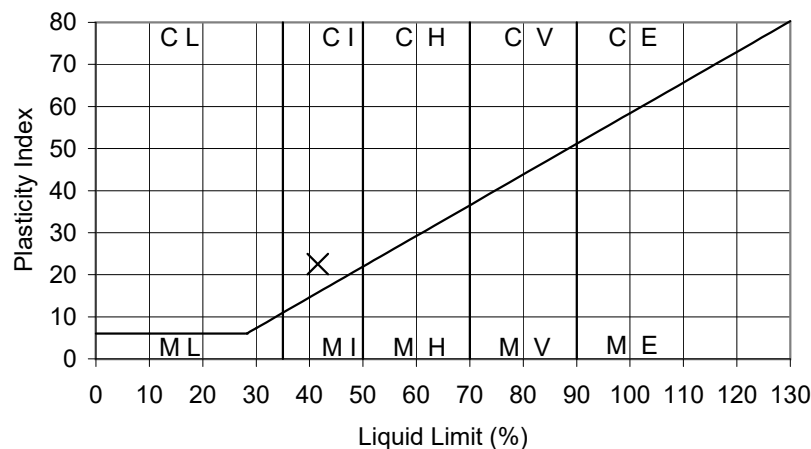
Non Engineering Description : Grey very sandy CLAY with much gravel. Gravel is fine to cobble sized.

As Received Moisture Content : (BS1377:Part 2:Clause 3:1990) 15 %
 Percentage retained on 425µm sieve : 56 %
 Liquid Limit : 42 %
 Plastic Limit : 19 %
 Plasticity Index : 23
 Equivalent moisture content of material passing 425µm sieve : 34 %
 Liquidity Index : 0.65

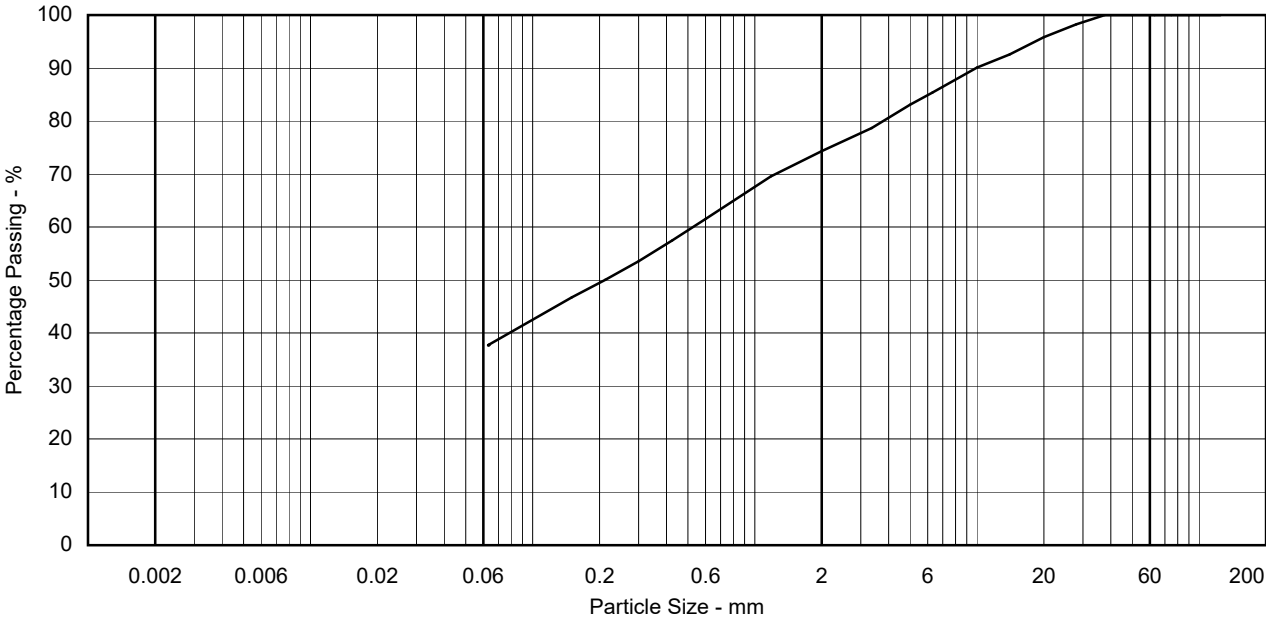
Originator	Checked & Approved	<div> <div>PARTICLE SIZE DISTRIBUTION</div> <div>BS1377:Part 2:1990 Clause 9.2 - Wet Sieving</div> </div>	<div> <div>Tk</div> <div>Figure 13</div> <div>Sheet 1 of 1</div> </div>
TH/ME	 11/09/2018

<div> <div>TERRA TEK</div> <div>SITE INVESTIGATION AND LABORATORY SERVICES</div> </div>	Site	SHIRES LANE	Contract No	3161
	Client	Lithos Consulting Ltd	Hole	TP09
	Engineer		Sample Ref	3
			Depth (m)	1.80
			Sample Type	B
