Geoenvironmental Appraisal

Land at Shires Lane, Embsay For The Devonshire Group

Report no: 3161/1A

Date: November 2018

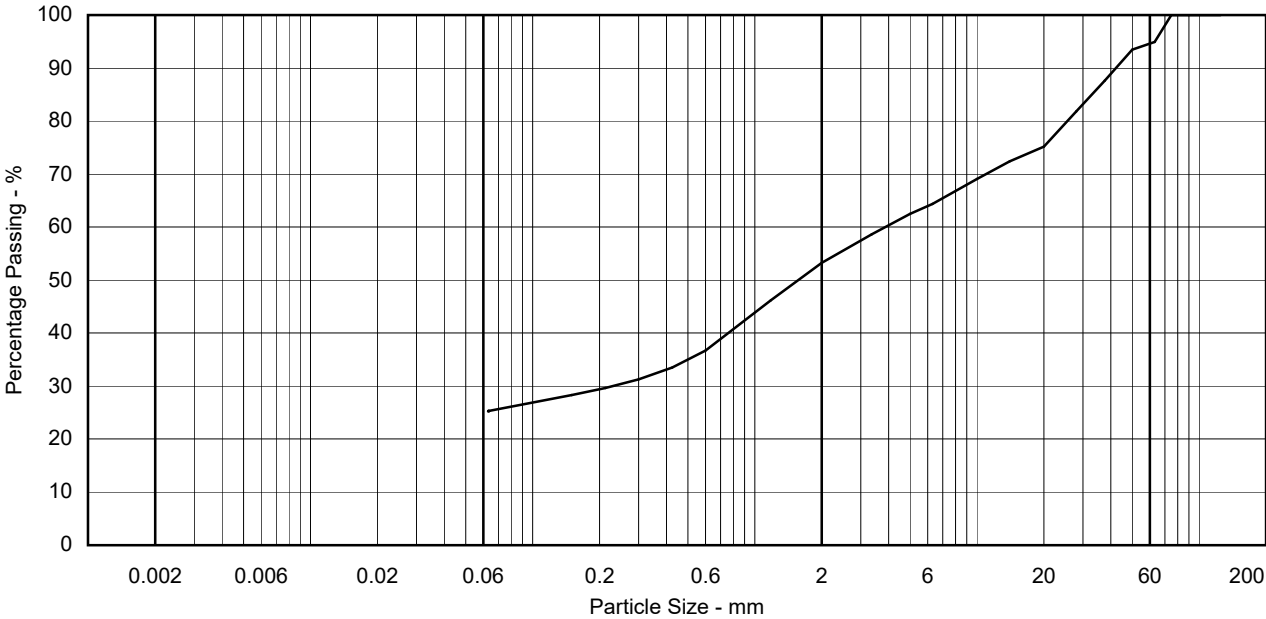
Originator	Checked & Approved	PARTICLE SIZE DISTRIBUTION BS1377:Part 2:1990 Clause 9.2 - Wet Sieving	Figure 14 Sheet 1 of 1
ME	<i>S. Langman</i> 11/09/2018
